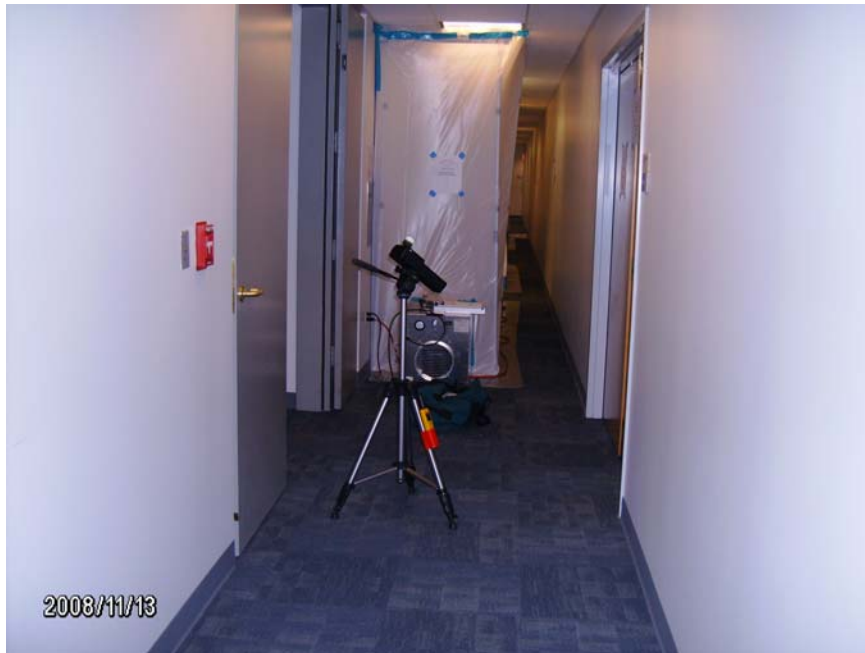
- 1) Image of hallway containment air sampling location on 24th floor of BOE building (Subject Building) located at 450 N Street, Sacramento.

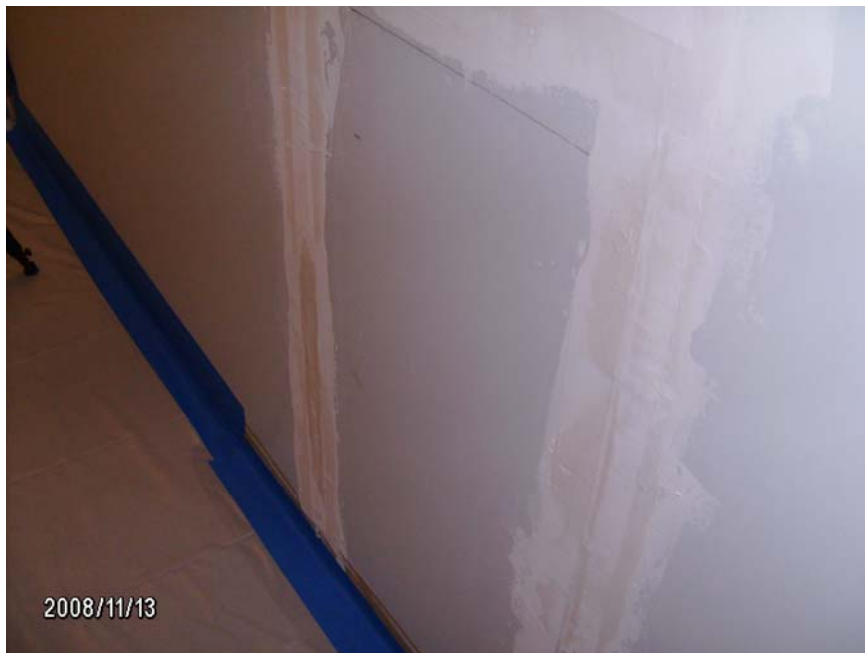
- 2) Image of wallboard repair within interior of LCD-C-1 containment area at time of assessment. Note sheetrock repair at area formerly removed for inspection.

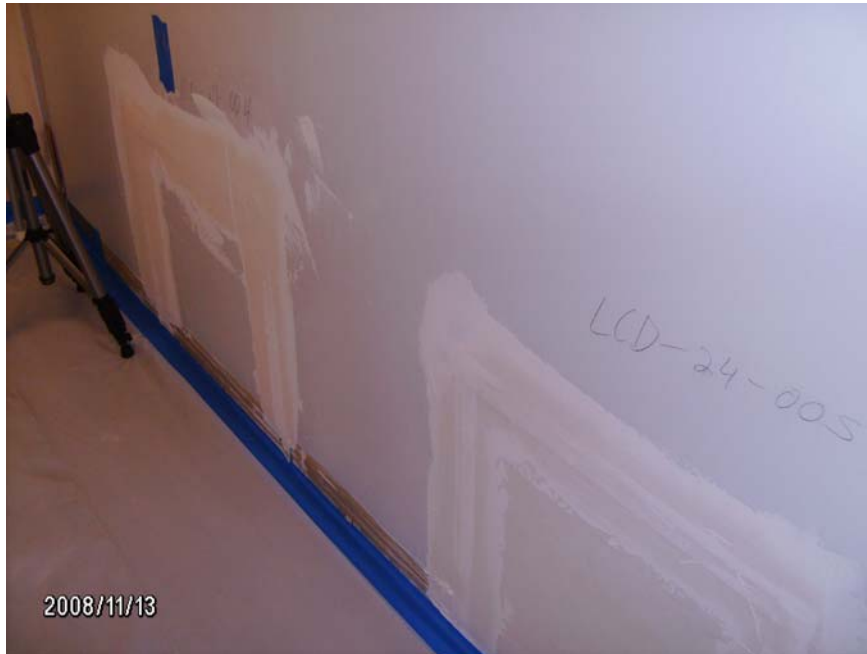
3) Image of reconstructed wall within interior of containment LCD-C-2 at time of assessment.

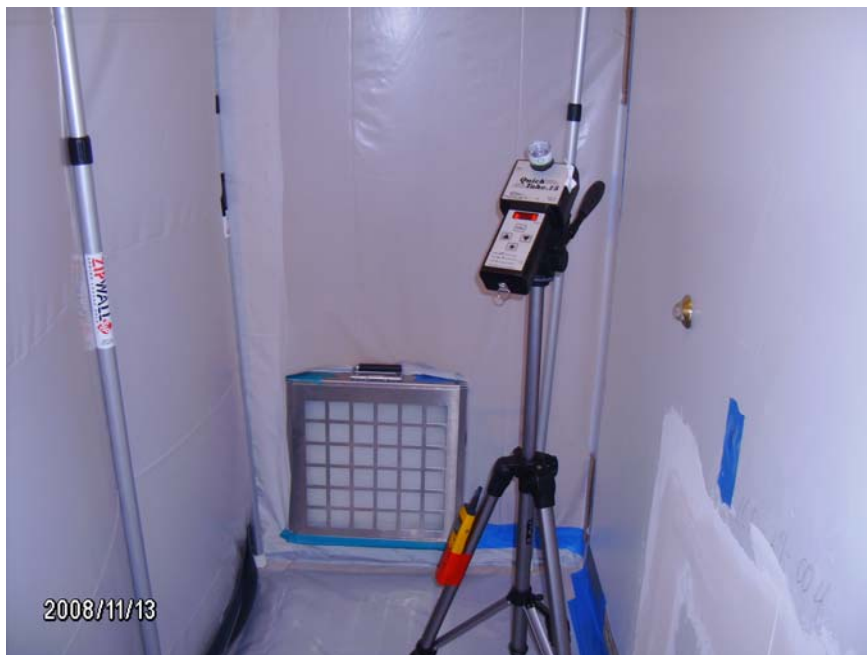
4) Image of interior entry chamber construction and air sampling activity performed within LCD-C-2 at time of assessment.

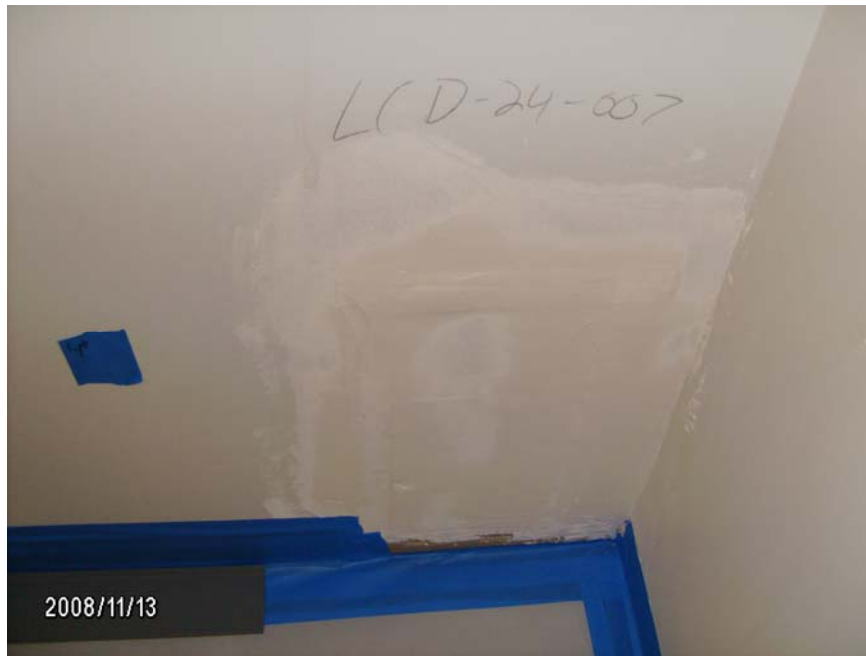
5) Image of baseboard removal and wall repair within LCD-C-3 at time of assessment.

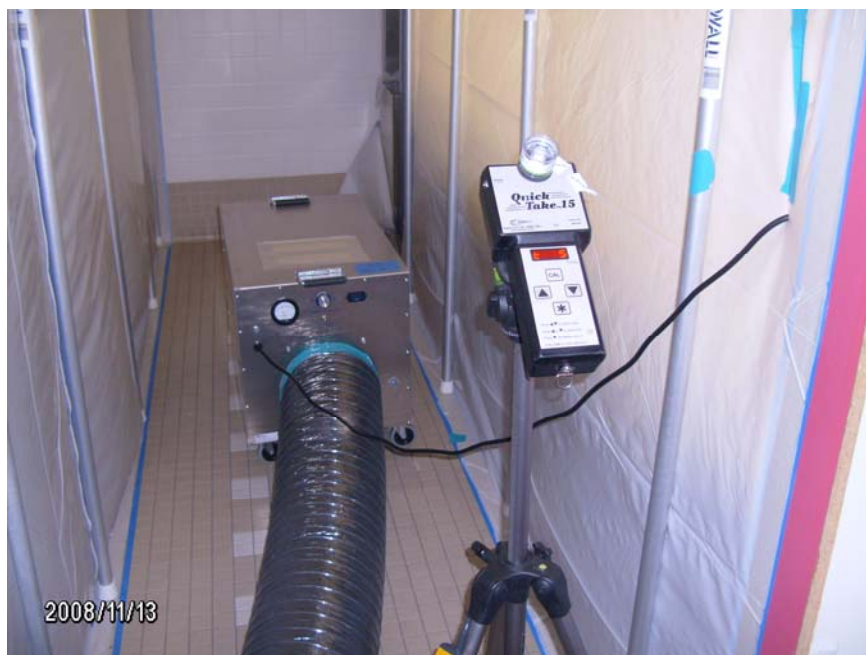
6) Image of air sampling activity performed within Women's Restroom LCD-C-4 at time of assessment.

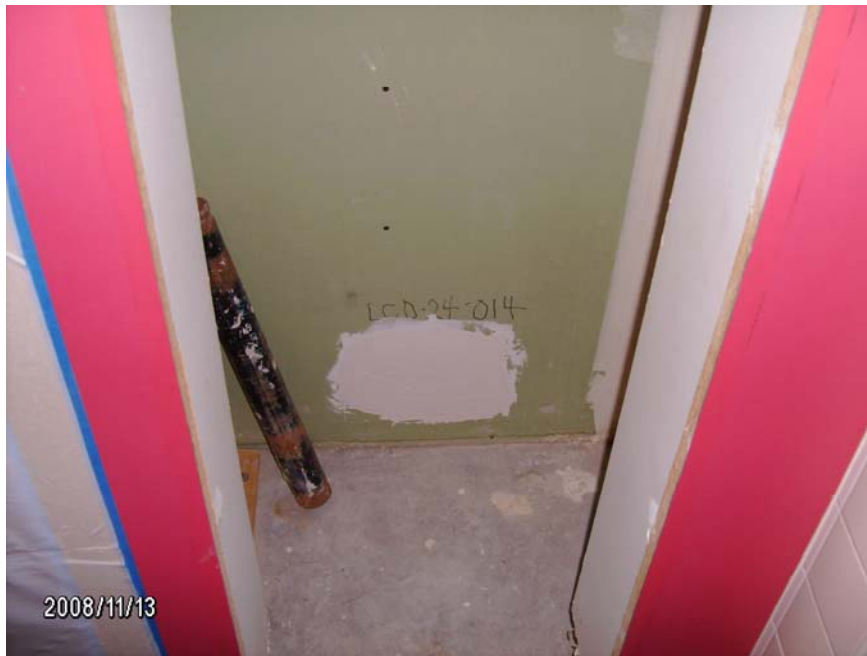
- 7) Image of exposed wall cavity as viewed from interior side of containment LCD-C-4 at time of assessment.

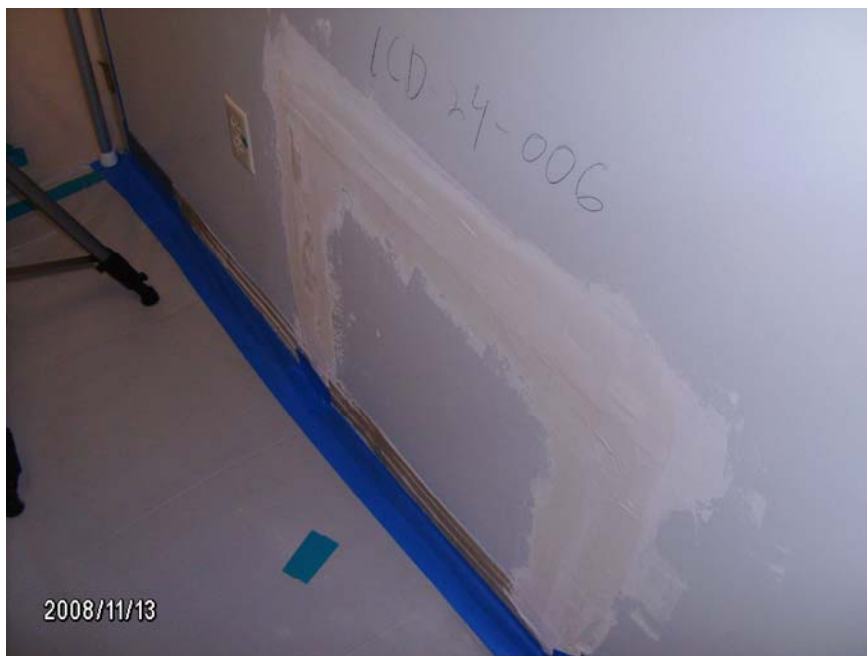
- 8) Image of wallboard repair within LCD-C-5 containment area at time of assessment.

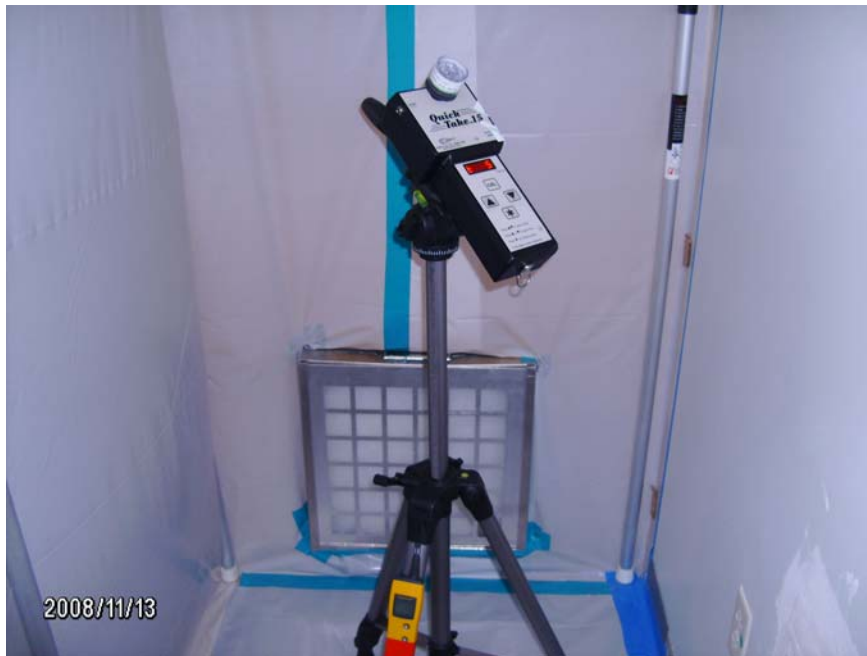
- 9) Image of air sampling equipment and critical barriers erected within LCD-C-5 containment system at time of assessment.

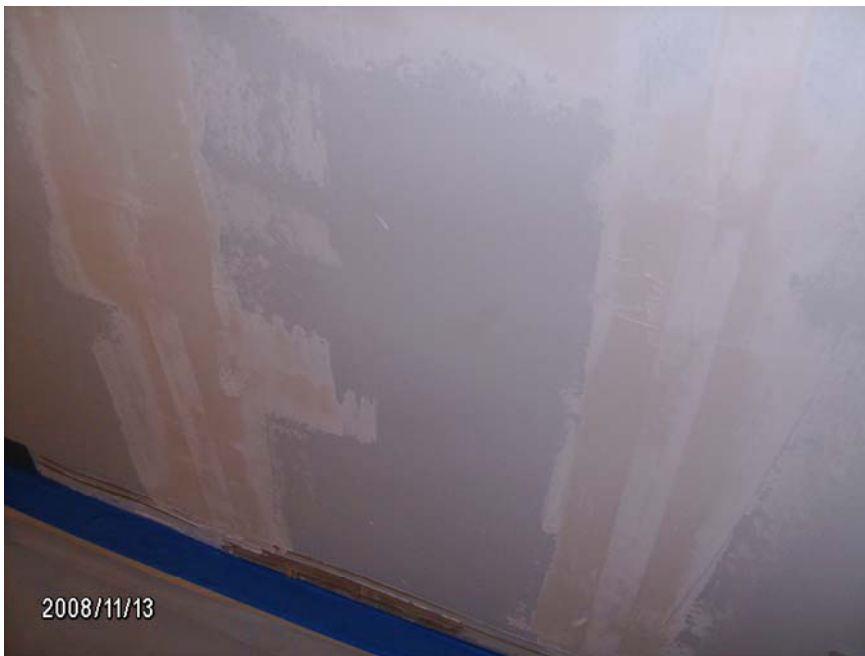
- 10) Image of baseboard removal and wallboard repair following LCD's inspection within LCD-C-6 at time of clearance assessment.

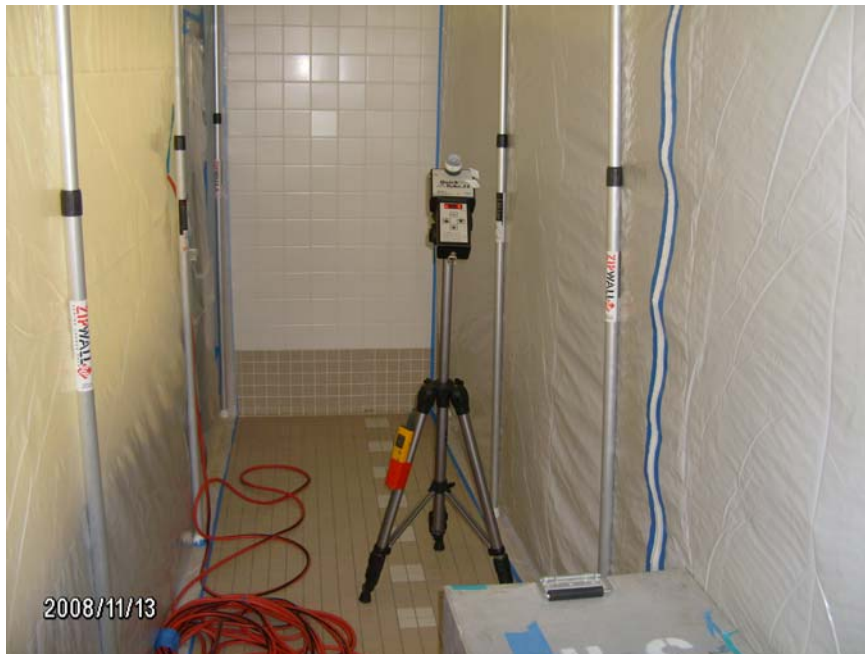
11) Image of air sampling equipment and containment structures within LCD-C-7 containment at time of assessment.

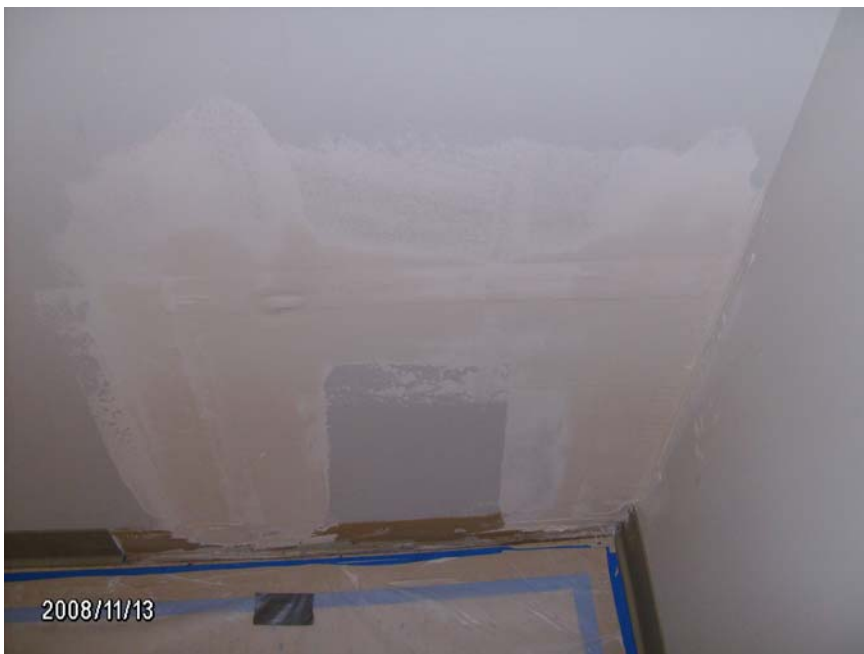
12) Image of wallboard repair within LCD-C-8 containment at time of assessment.

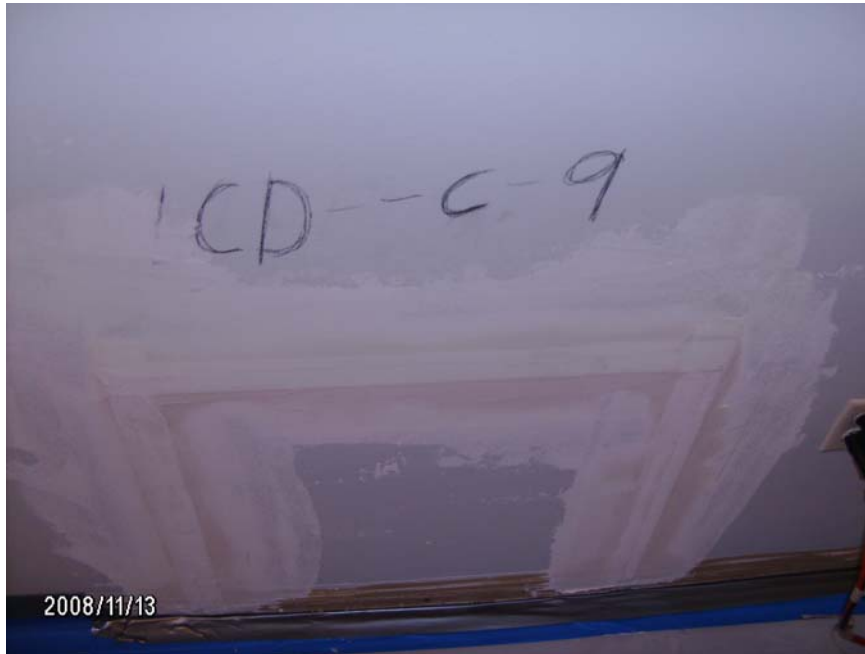
13) Image of wallboard repaired following LCD inspection within LCD-C-9 containment at time of assessment.

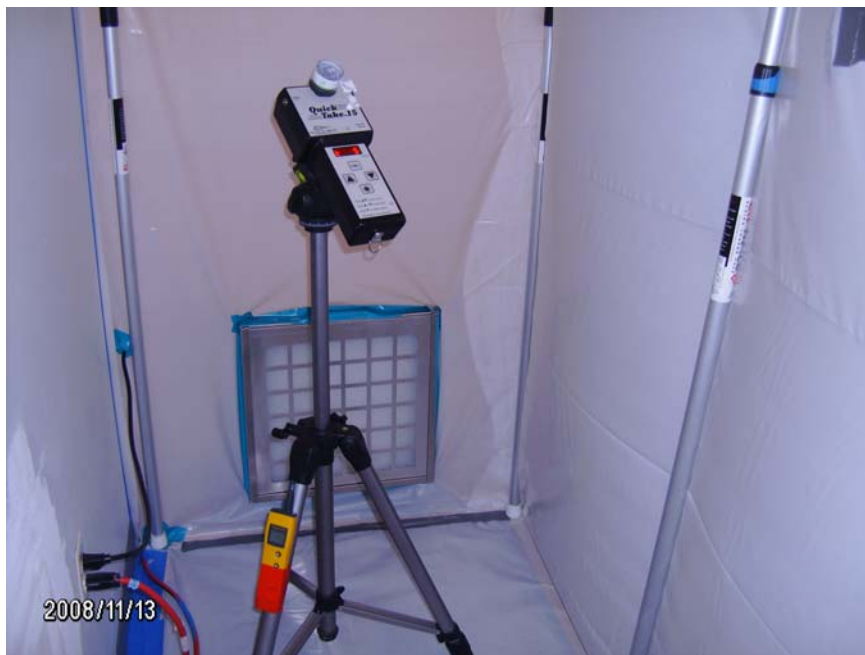
14) Image of air sampling equipment within LCD-C-9 performed at conclusion of interior clearance inspection sampling.
